Uniden® Bearcat BC-800 XLT

**Uniden® Bearcat BC-800 XLT
IC8 & IC9 Voltage Pin-Out Information**

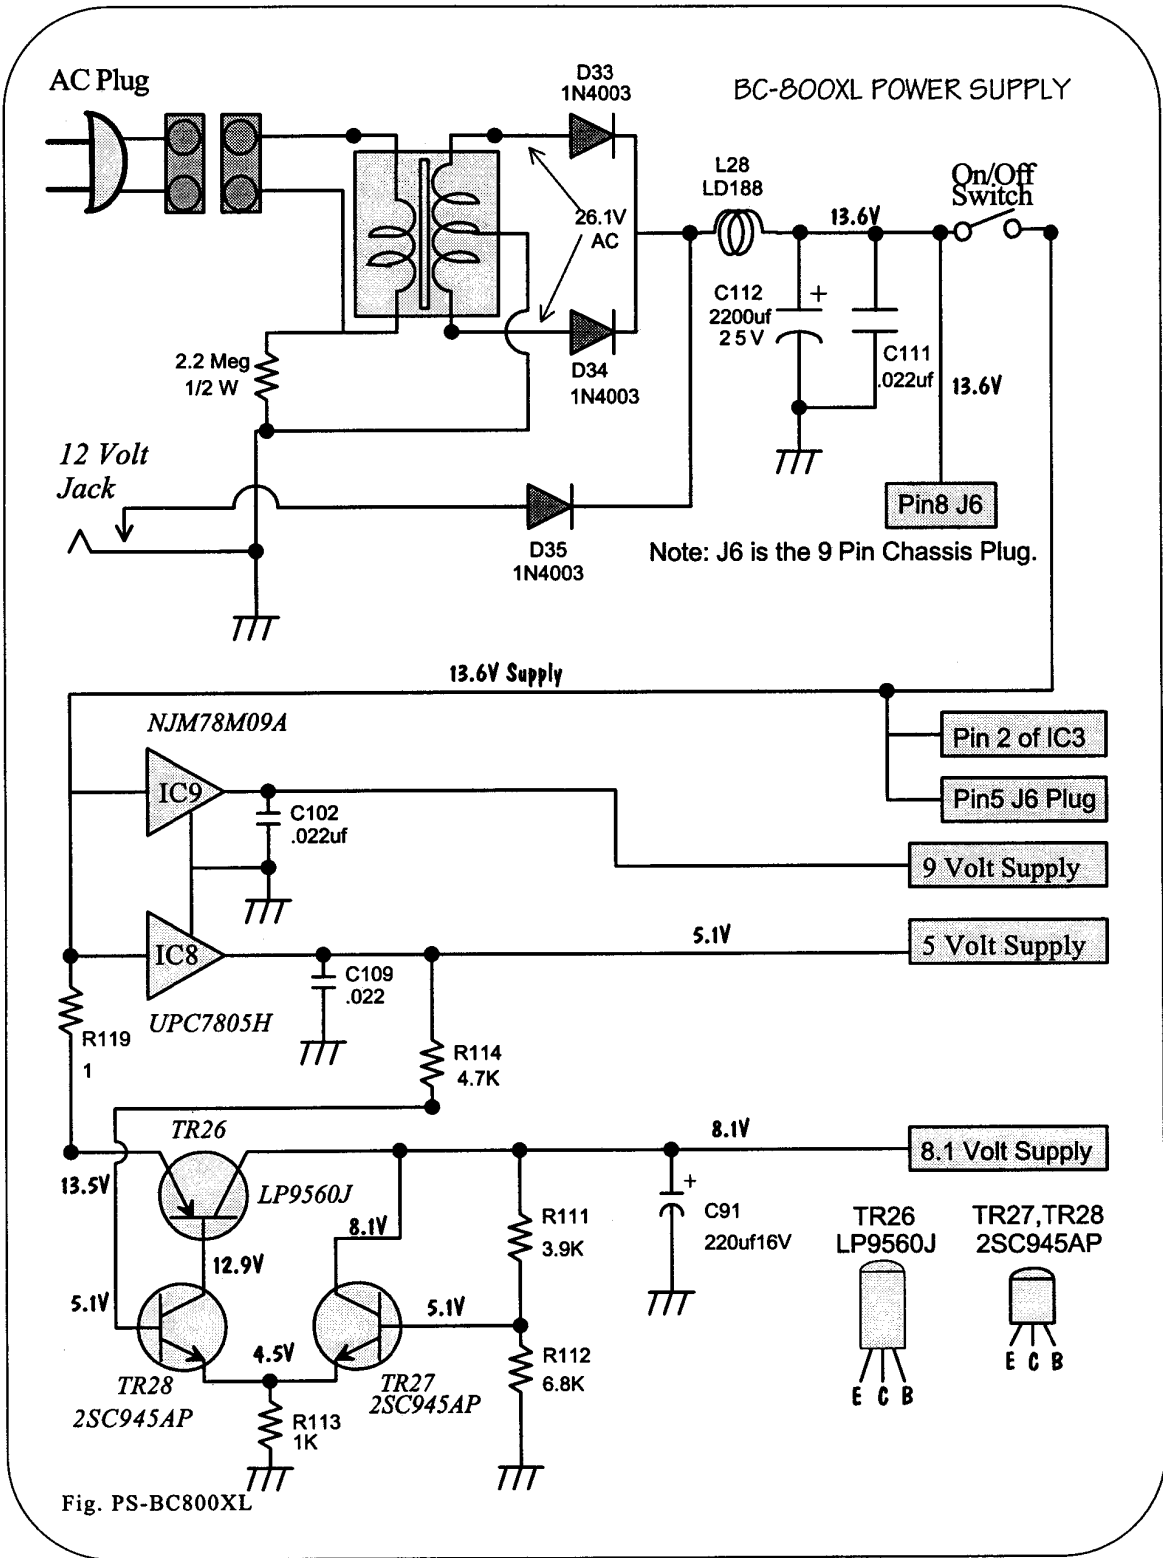
Fig. PS-BC800XL

IC8 & IC9 are both voltage regulators which supply the 5.00 vdc & 9.00 vdc for circuit operation. The 7805 regulator seems to fail more often. This should be one of the first areas to check in case of failure.

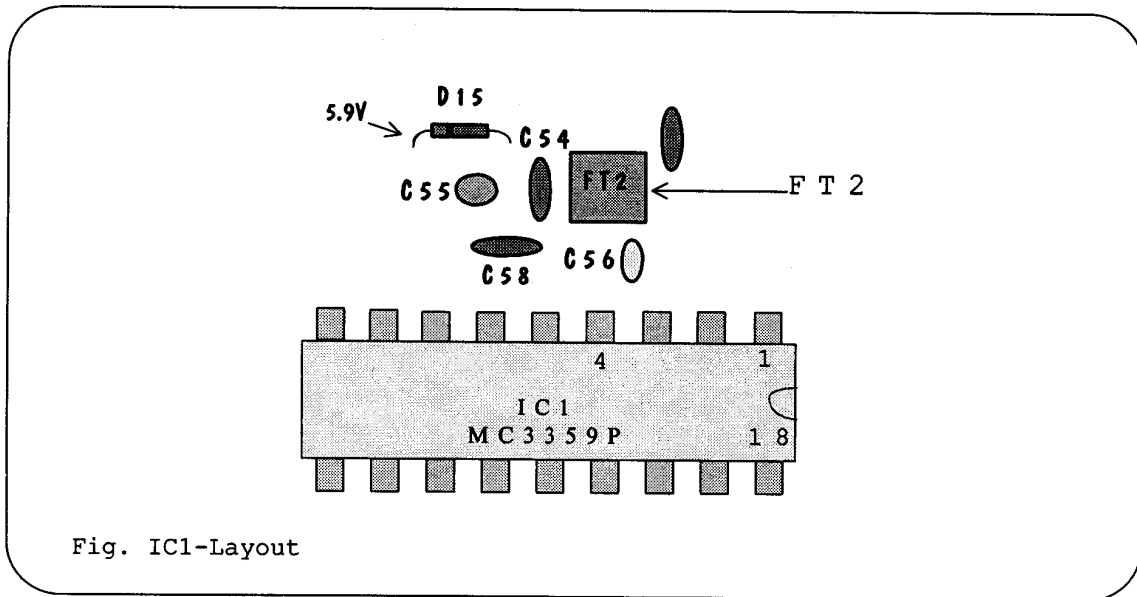
Uniden® BC-800XL
IC1 Layout

PROBLEM: Unit does not Scan, has no Audio or Squelch. Unit still programs and has digital display. Voltage on Pin 4 of IC1 checks OK. IC1 feels very warm to the touch.

CURE : Check the remaining voltages on IC1. If these voltages are not within tolerances then IC1 has failed and will need to be replaced. An NTE-860 or RCA SK7731 is the direct replacement for this chip. This chip has connections on both sides of the circuit board, and will need to be carefully unsoldered with a good brand of solder-wick in order to remove all existing solder. This will prevent any circuit board damage from occurring when you remove the old chip. After replacing IC1 you should find that you now have normal operation.

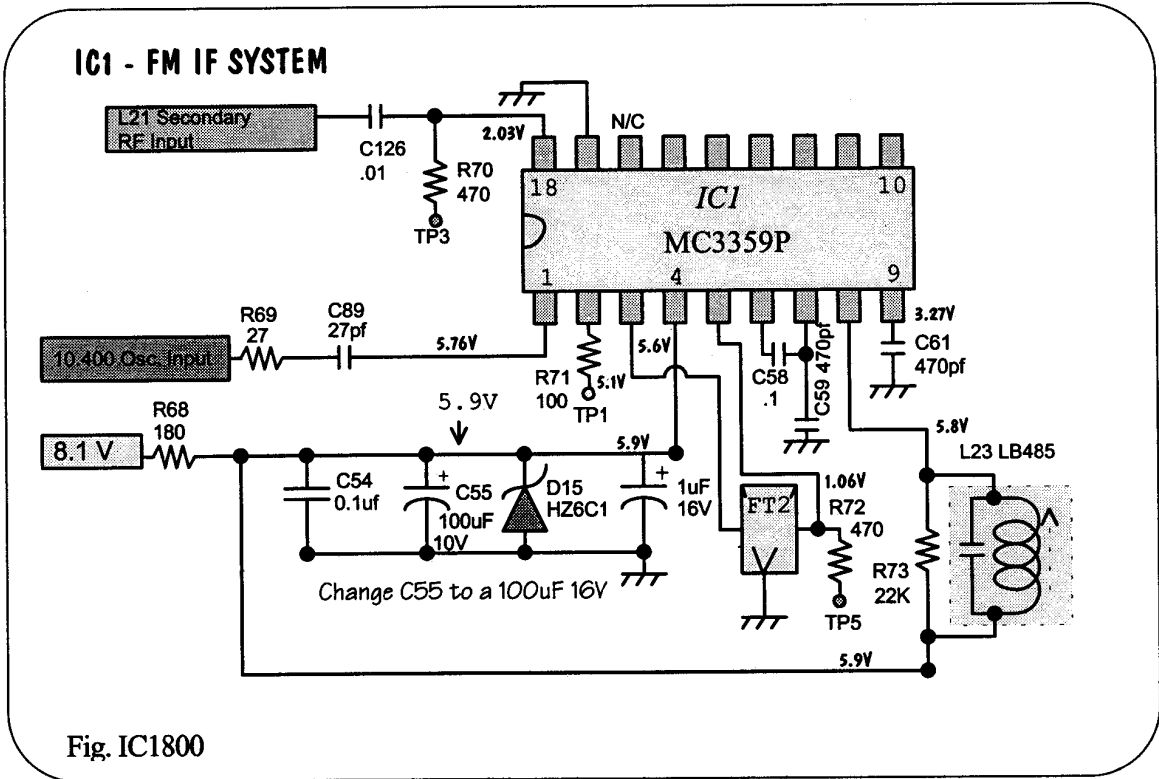
PROBLEM: Unit does not Scan, has no Audio or Squelch. Unit still programs and has digital display.

CURE : Locate IC-1 (MC3359P FM IF CONVERTOR) 18 pin chip. Check the Voltage on Pin 4. This voltage should read about 5.9 Volts. If this voltage is absent or very low the suspect part is C55, a 100uf 10Volt electrolytic capacitor. C55 is located next to FT2, a black filter with the #CFU 455 on it. Replace C55 with a 100uf 16 Volt or higher capacitor. After replacing C55 you should now have voltage on pin 4 of IC-1 and the unit should now function properly. If this voltage is still not correct replace D15 (HZ6C1) zener. Replace D15 with a 6.1 volt 1/2 watt. An NTE-5012A is a direct replacement.

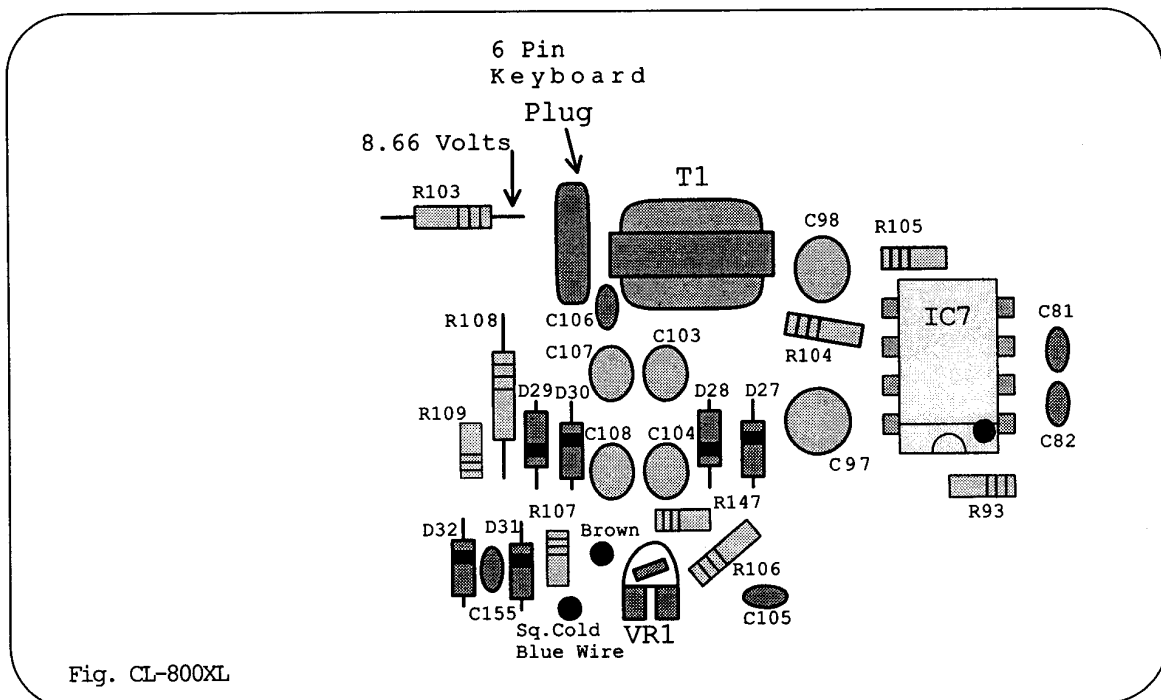
Component Locations

PROBLEM: Unit has no digital display or digits are very dim. Unit will not program and has no receive. Resistor R103 is getting very warm or has opened up.

CURE : Check for 8.6 volts on Pin 6 of IC7. If this voltage is absent and R103 shows the above mentioned signs then C97 (220uf 10v) has shorted. Replace C97 with a 220uf 16V or higher voltage rating. If R103 (2.2 Ohm) has changed value or opened up you will need to replace it also. Once this is done you should now have 8.6 volts on Pin 6 of IC7. In some cases the 9 volt regulator has also been damaged by the excessive current drain caused by the shorted C97. Replacement of the 9 volt IC regulator may be required also.

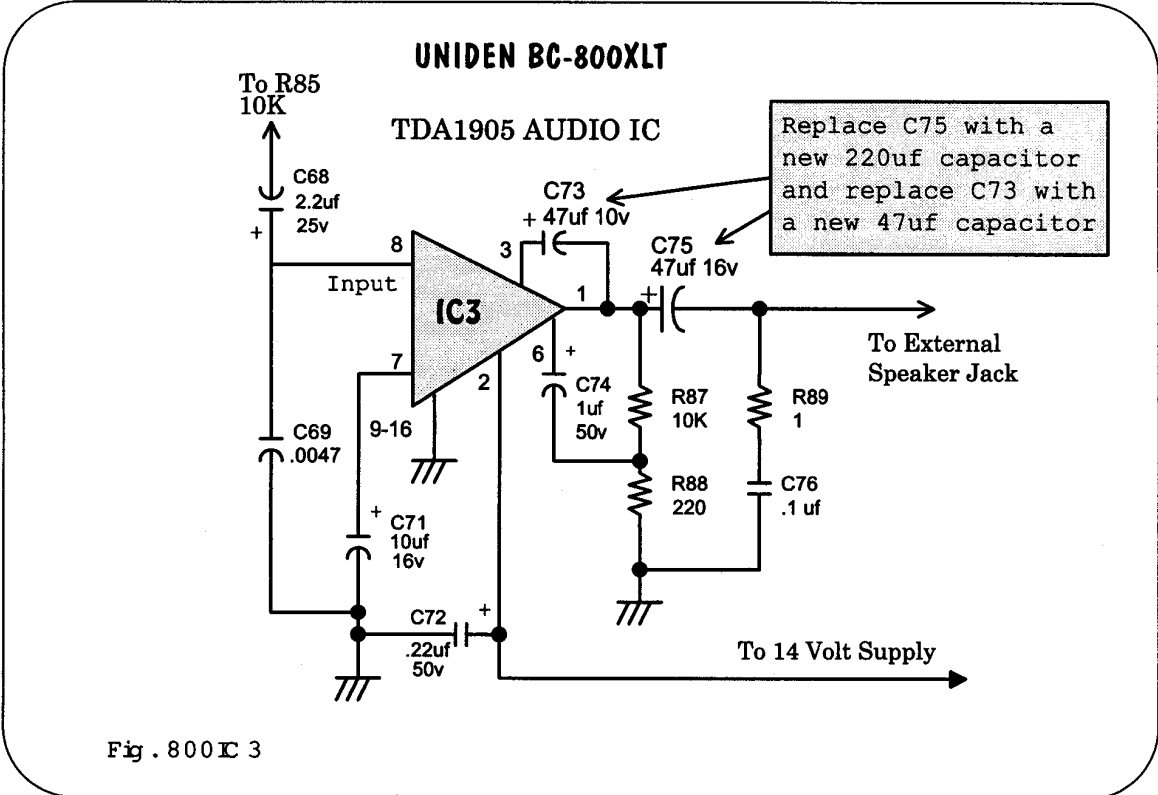
PROBLEM: Distorted Audio, Speaker Sounds Bad, however unit still sounds distorted with an external speaker connected. Voltages check OK on Audio Chip.

CURE : This problem has been traced to the coupling capacitor (C75) which connects the Audio Chip output on Pin 1 to the speaker and/or the feedback capacitor (C73) connected between Pin 3 and Pin 1 of the Audio Chip. C75 is a 47uf 16 Volt electrolytic capacitor, and C73 is a 47uf 10 volt electrolytic capacitor. First you will need two replacement capacitors. A 47uf electrolytic (16 volt or higher) and a 220uf electrolytic (25 volt or higher). Next replace C75 with the new 220uf electrolytic and replace C73 with the new 47uf electrolytic. Observe polarity when replacing. Not only should this eliminate the problem, it will also greatly improve the scanner's audio quality.

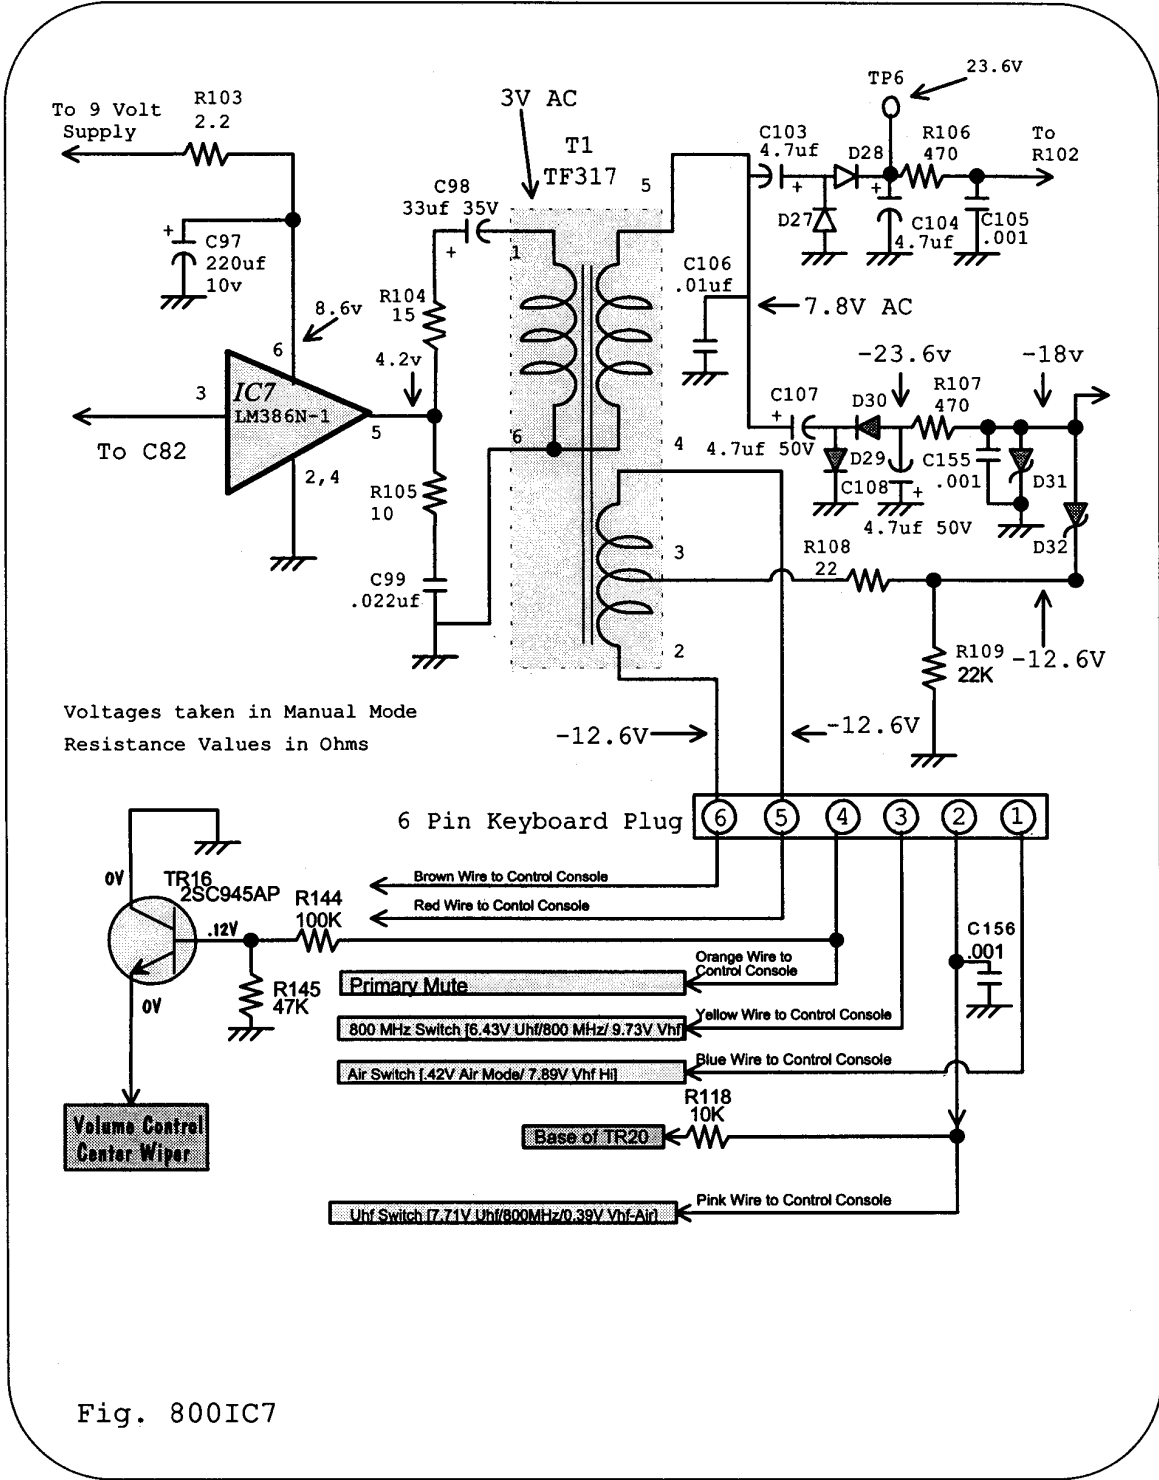
Fig. 800IC7

PROBLEM: Unit has no digit display or digits are dim. Unit will not program and/or has no receive.

CURE : Check for 4.16 Volts on Pin 5 of IC7. If this voltage is off or very low replace the 33uf 35 Volt electrolytic capacitor located between IC7 and transformer T1 (Labeled TF-317). Replace this capacitor with a 33uf 50 Volt. Be sure that the positive side of this capacitor goes toward pin 5 of IC7. Re-check pin 5 of IC7 for 4.15 volts. If this voltage is still off, T1 may be bad. The negative side of the 33uf 50volt capacitor goes to a winding of T1. The other side of this winding goes to ground. In some cases this winding may be open. Check for continuity of this winding. If open replace T1. Normally just replacing the 33uf capacitor will cure the problem in most units.
