Yaesu VX-1R

Frequency Shift Problem and Deviation Adjustment

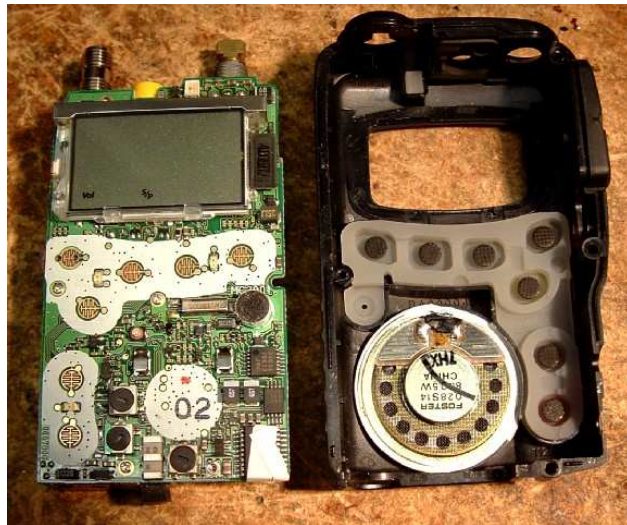
**Fig. 1 VX-1R
opened and main
board removed
from front panel**

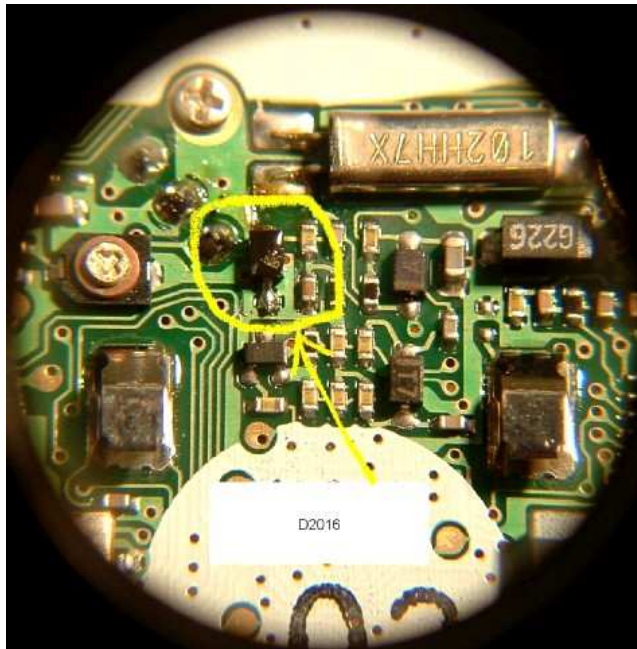
Fig. 2 D2016 location

If your VX-1R (any version) has suddenly changed frequency by up to 15 kHz; that is, the actual transmit or receive frequency is 13-15 kHz off of what the display indicates, the problem is a surface mount diode on the main circuit board that has been knocked loose by the speaker in normal use.

Now locate D2016 based on Fig. 2. Using liquid flux (preferably) and a GROUNDED 25 watt soldering iron, resolder both ends of D2016. Don't reassemble your radio just yet.

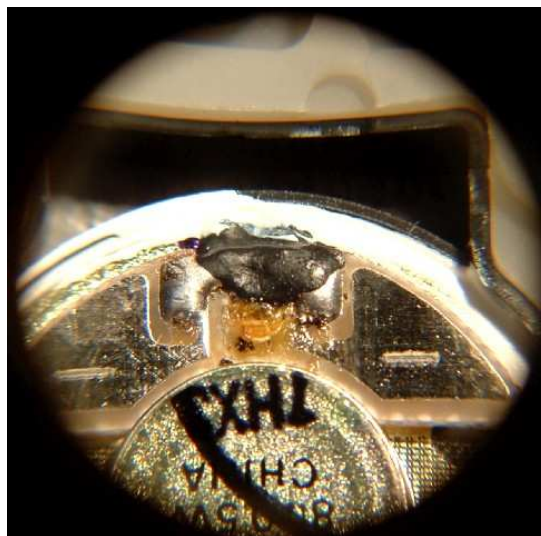
The original problem was caused by the black stabilizing compound “blob” on the top-back of the speaker. I was going to scrape a bit of it off to make room for D2016 but figured that the hair-fine wires for the speaker cone run through that stuff, and thought better of it. Better to just leave it be and repair D2016 again later if needed. See Fig. 3

Fig 3, Speaker detail showing black “blob” between the speaker contacts

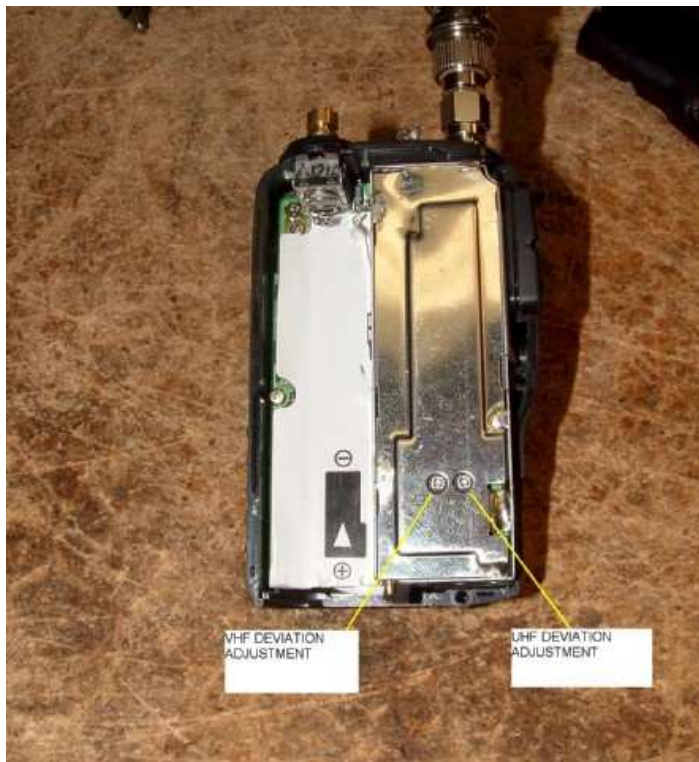
Fig. 4 Deviation adjustment for the VX-1R. VHF is on the left, UHF is on the right. Don't turn more than about 10-15 degrees CLOCKWISE to increase deviation.

While you are at it, you can adjust the deviation limit of the VX-1R. Almost all rigs are shipped with low deviation limits; a simple turn of two pots will do the trick. See Fig. 4. Use a small fine screwdriver and just turn the pots clockwise about 10-15 degrees rotation. If you start getting complaint of dropping out of a repeater on voice peaks you may need to turn them back down a little, so don't move them more than about 10-15 degrees. This gave us a good solid +/- 5 kHz deviation with sub-tone turned "on".
