## **A Practical and Simple Keypad Bounce Filter for the Kenwood R-5000**

This modification was reported in the Kenwood R-5000 Yahoo! Group by Ron Hankins (KK4PK). This documents my implementation of Ron's solution to this annoying and long lived problem with this otherwise good communications receiver.

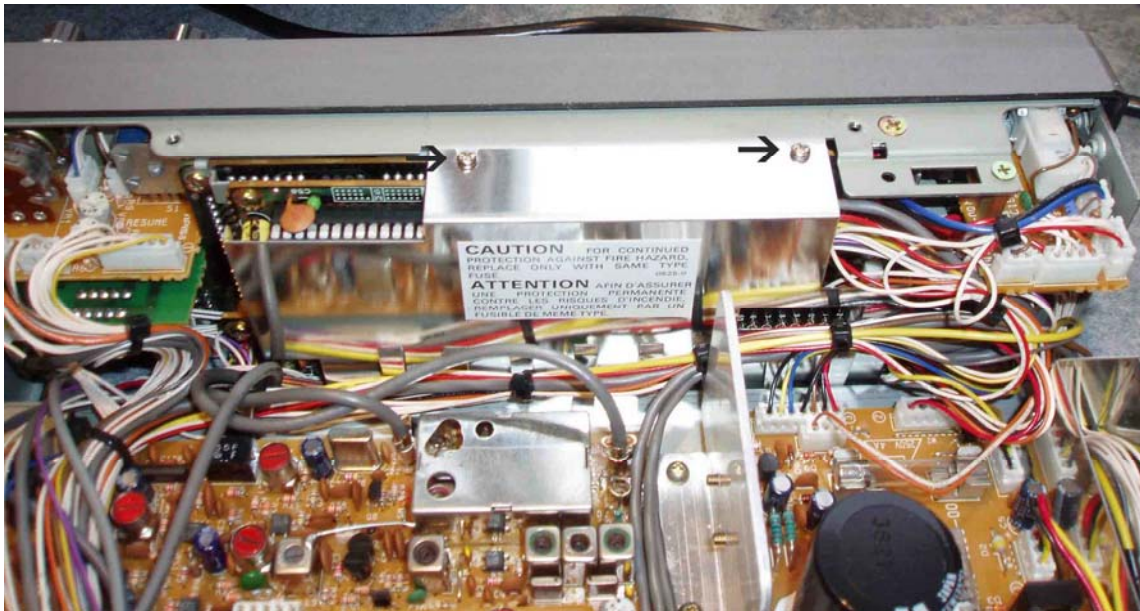
Top view

Remove the top and bottom covers and set them aside after disconnecting the speaker wire, Loosen but do not remove the small screws indicated by the arrows as shown in the two pictures below.

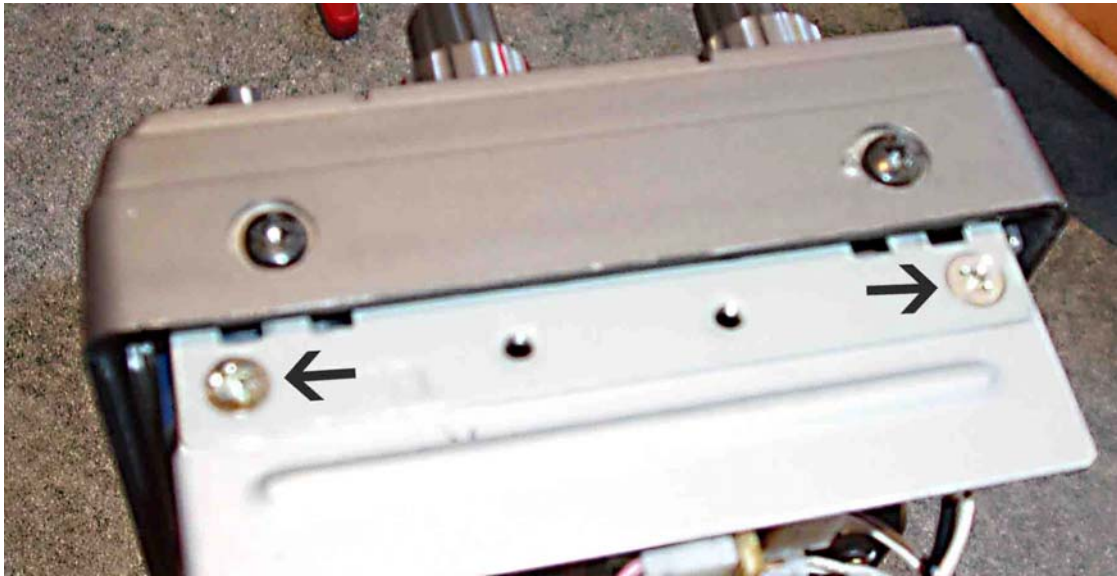
Remove the two countersunk screws holding the front panel in place as shown below.

Remove the screws from both sides and gently separate the front panel from the chassis. The shield can now be removed by sliding it towards the back and carefully removing it.

**Front panel attachment screws**

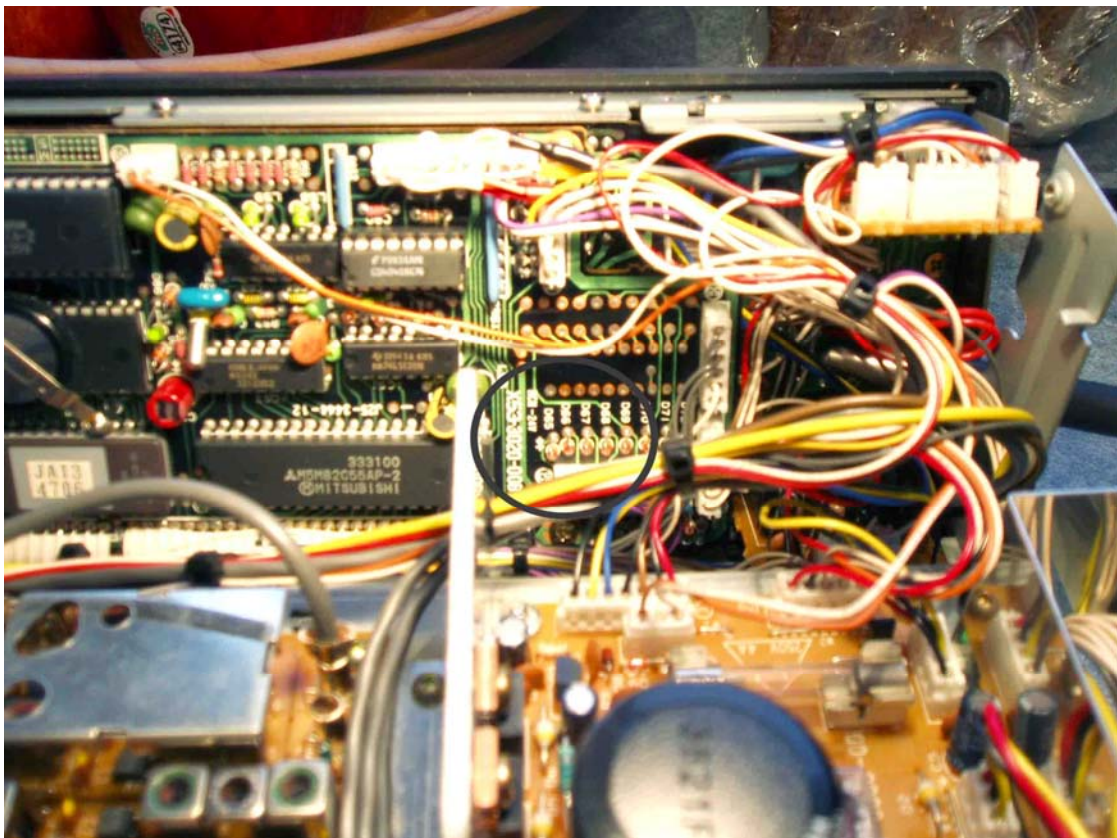
With the shield removed, you should be able to locate the circled area shown in the image below.

**The area where the caps will be attached**

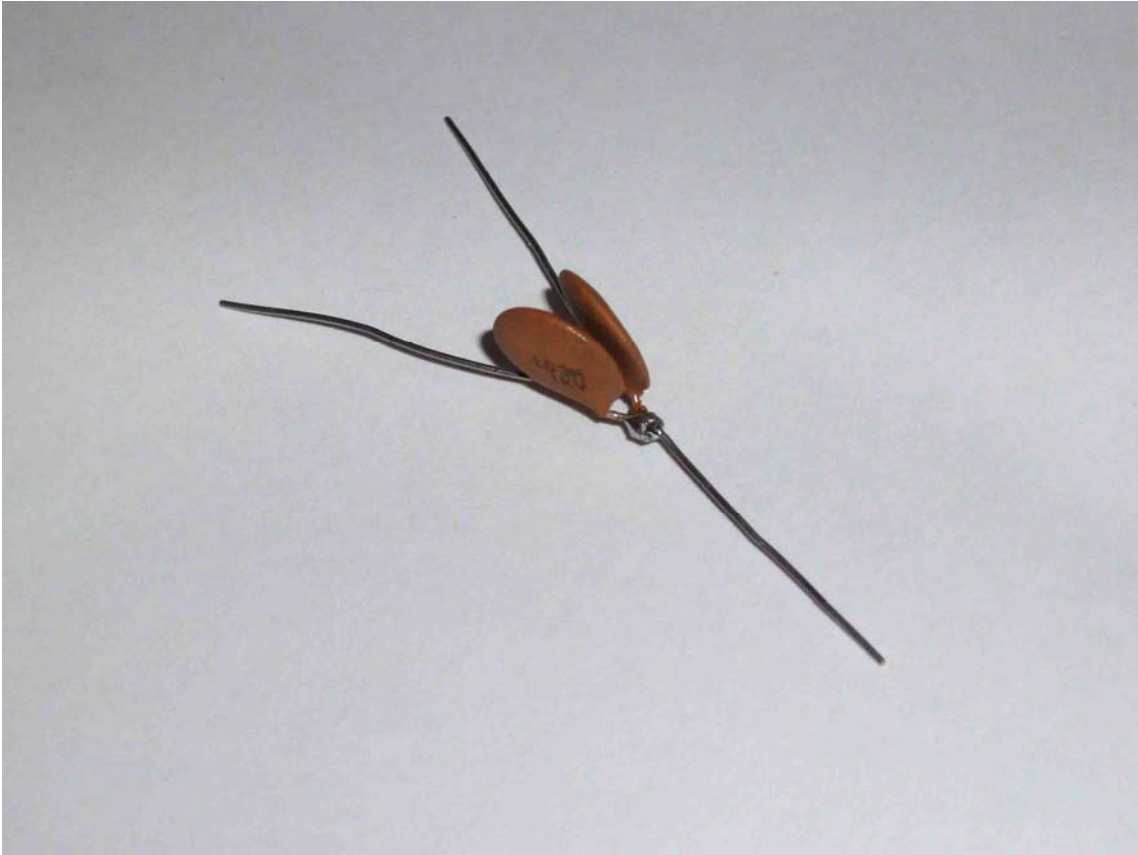
Preassemble two .01 ufd disc ceramic caps as shown in the picture below.

### Capacitor assembly

My caps happened to be 1Kv types and were 10mm (3/8") in diameter.  
Now turn the radio so the bottom side is up and locate the solder pad located between the pc board mounting screw and C52 as shown in the picture below

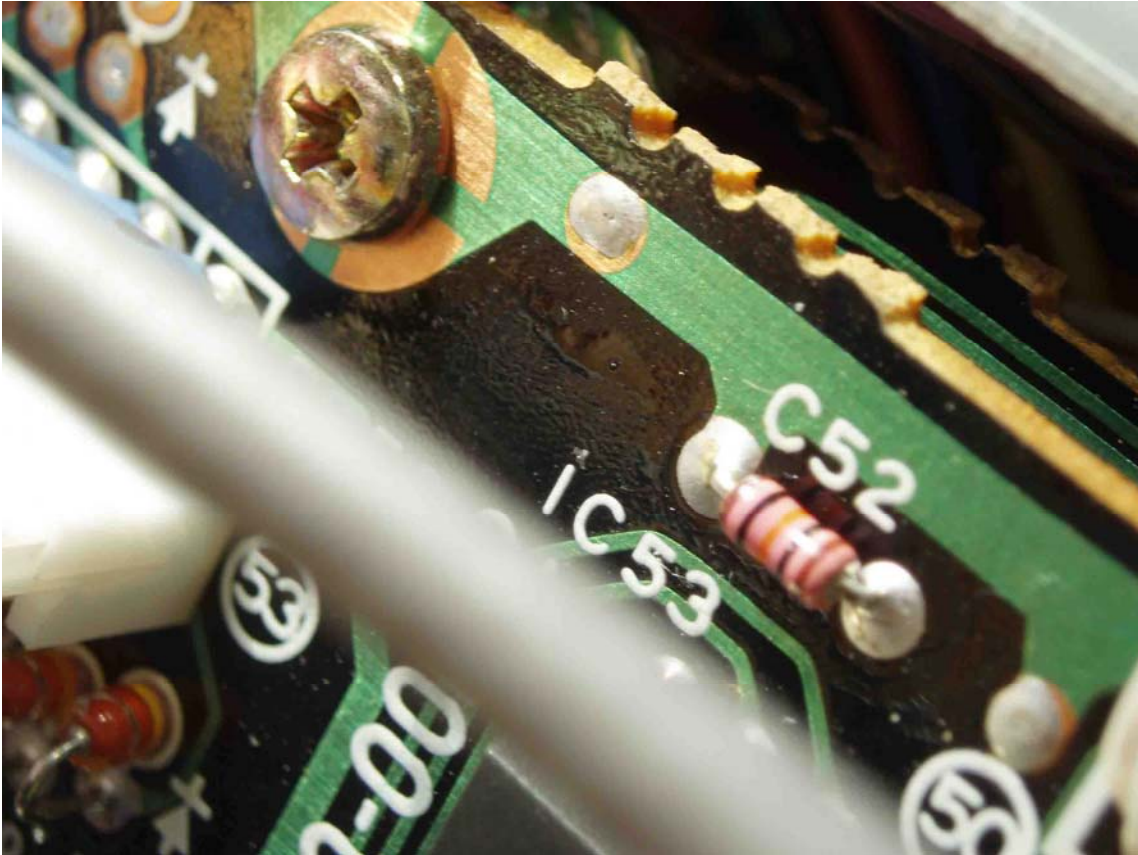
**Ground solder pad**

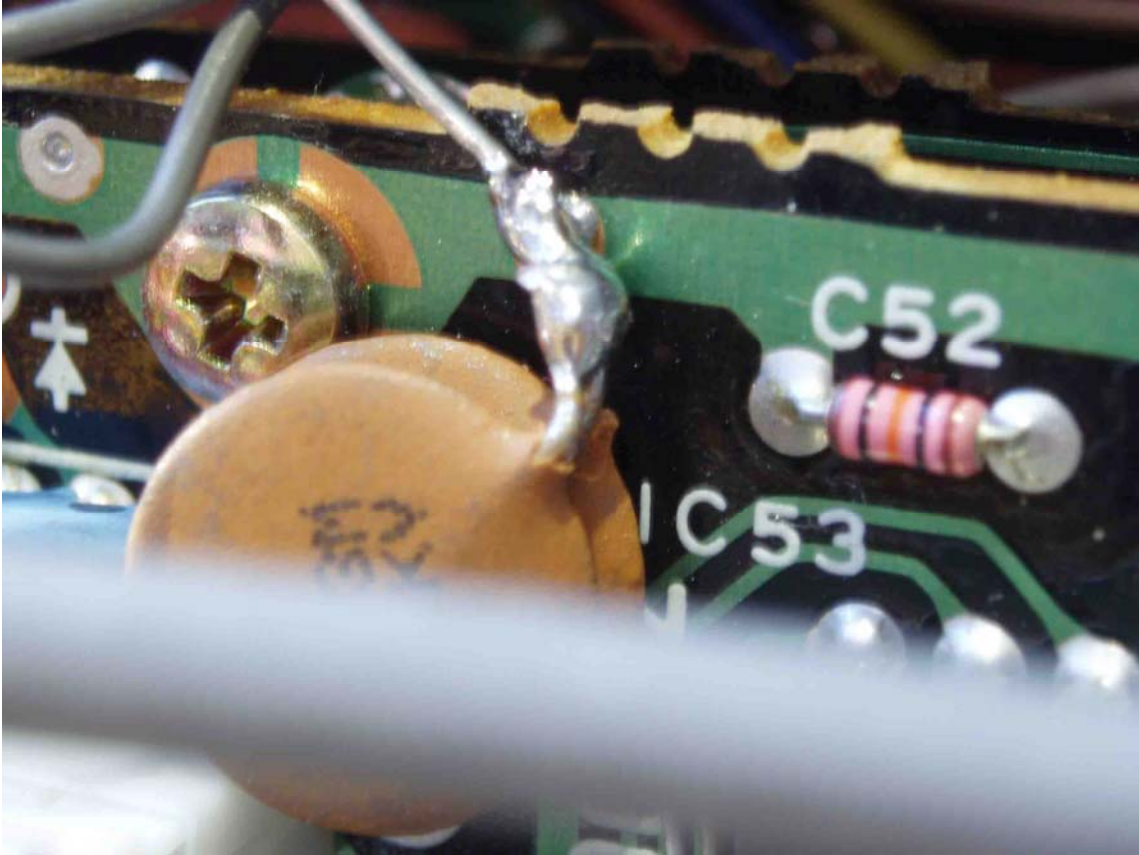
Using a small pencil soldering iron, tack a small blob of solder to this pad and attach the cap assembly as show below. Cut the wire tail off after you have made a good solder connection.

**Capacitor assembly ground side attachment**

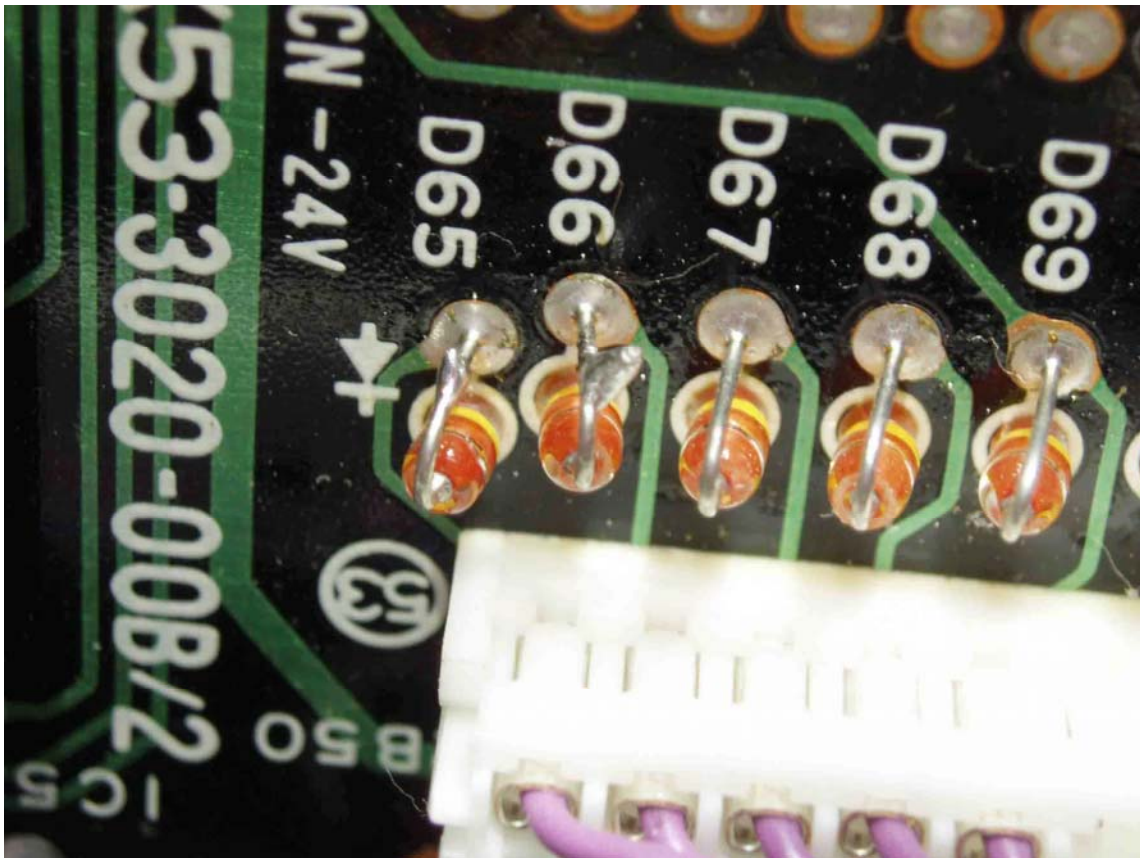
Now turn the radio right side up. and locate the anodes for diodes D65 and D66.  
Using a low wattage pencil iron, Tin the wire loops on these two diodes as shown below.

#### **D65 and D66 Anode connections**

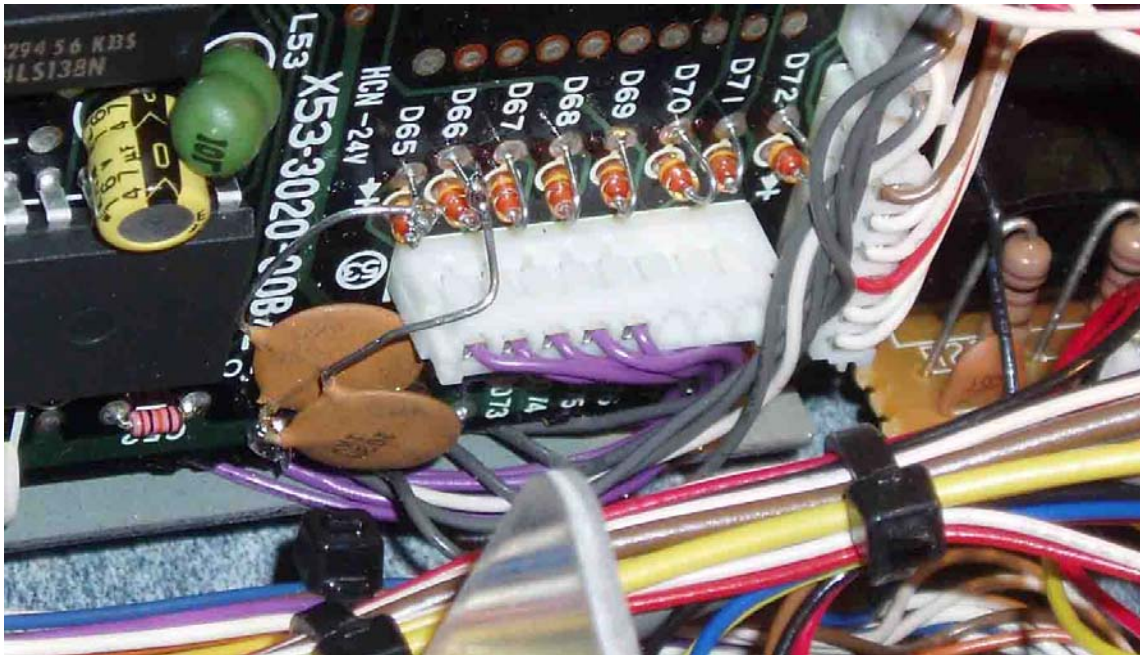
The final step is to solder the two remaining capacitor leads to the diodes. Carefully dress the capacitor leads so that they do not touch anything other than D65 and D66 anode leads.

Pre-tin the capacitor leads and tack them into place as shown below

**D65 and D66 Attached to the caps**
