Uniden® Bearcat BC-800 XLT

**Uniden® Bearcat BC-800 XLT
IC8 & IC9 Voltage Pin-Out Information**

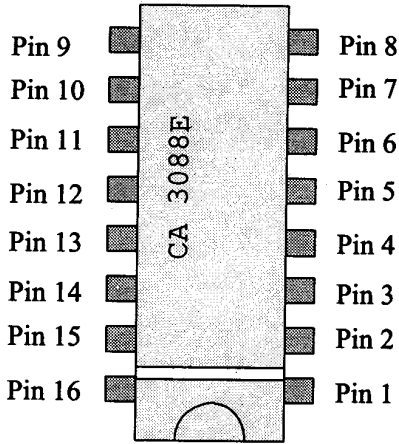
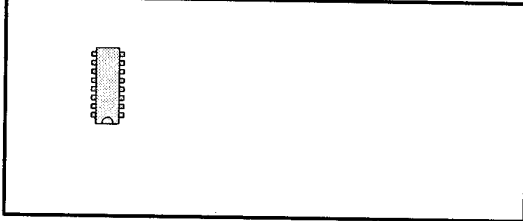
Fig. IC2-BC800XLT

IC2 - AM IF CONVERTOR

PROBLEM: Unit has no digit display or digits are dim. Unit will not program and/or has no receive.

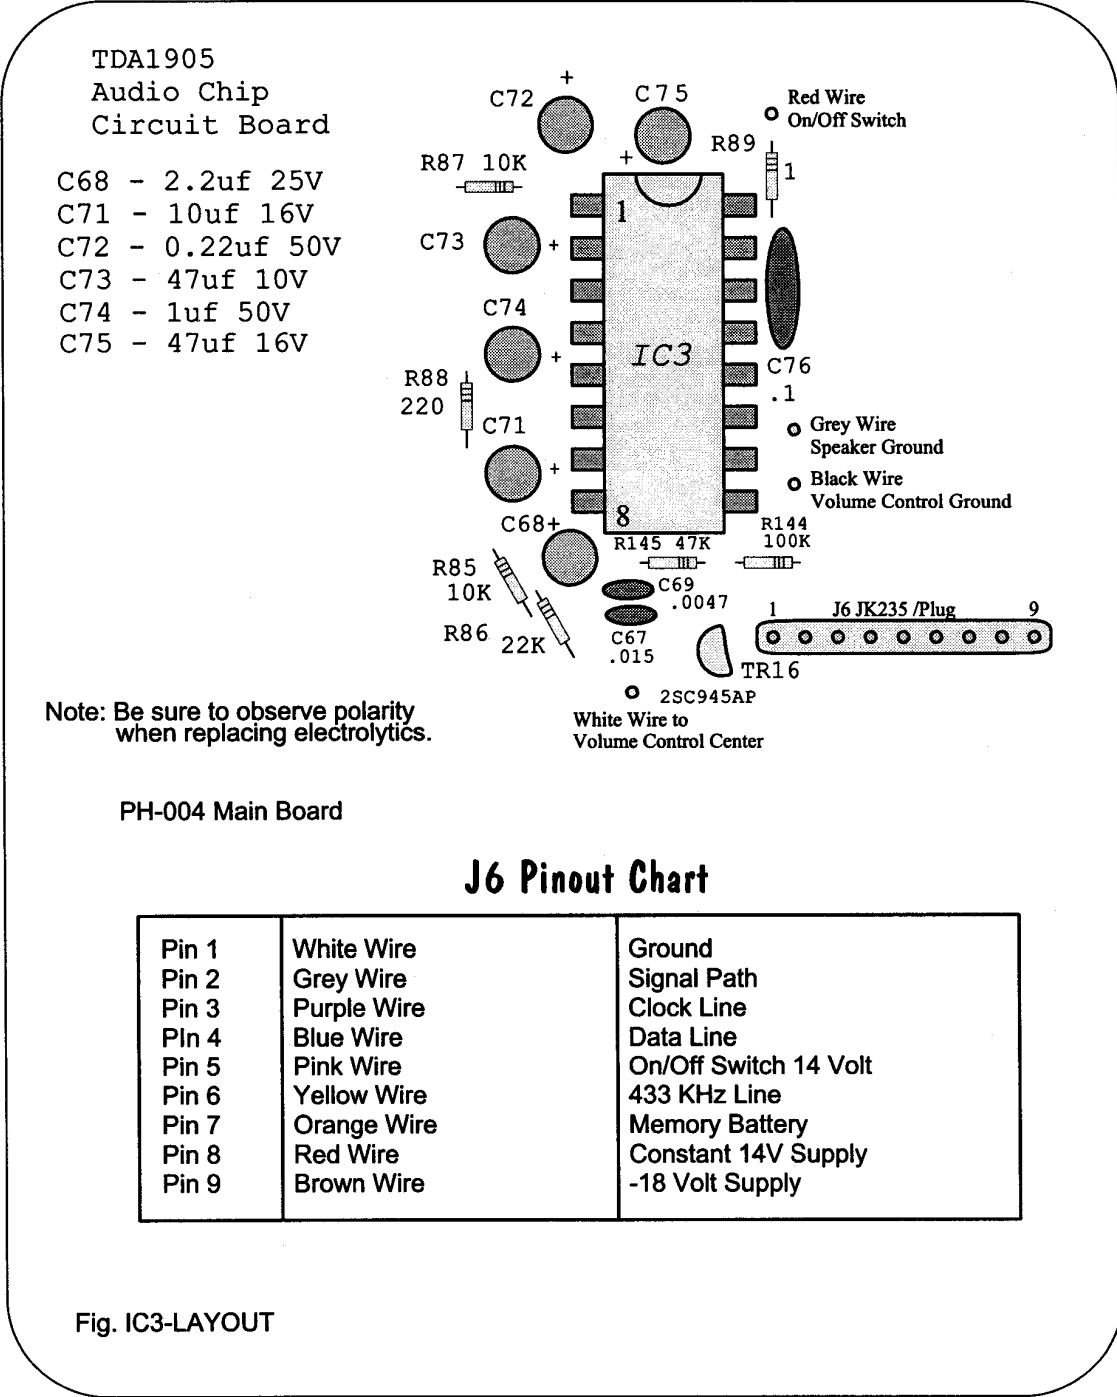
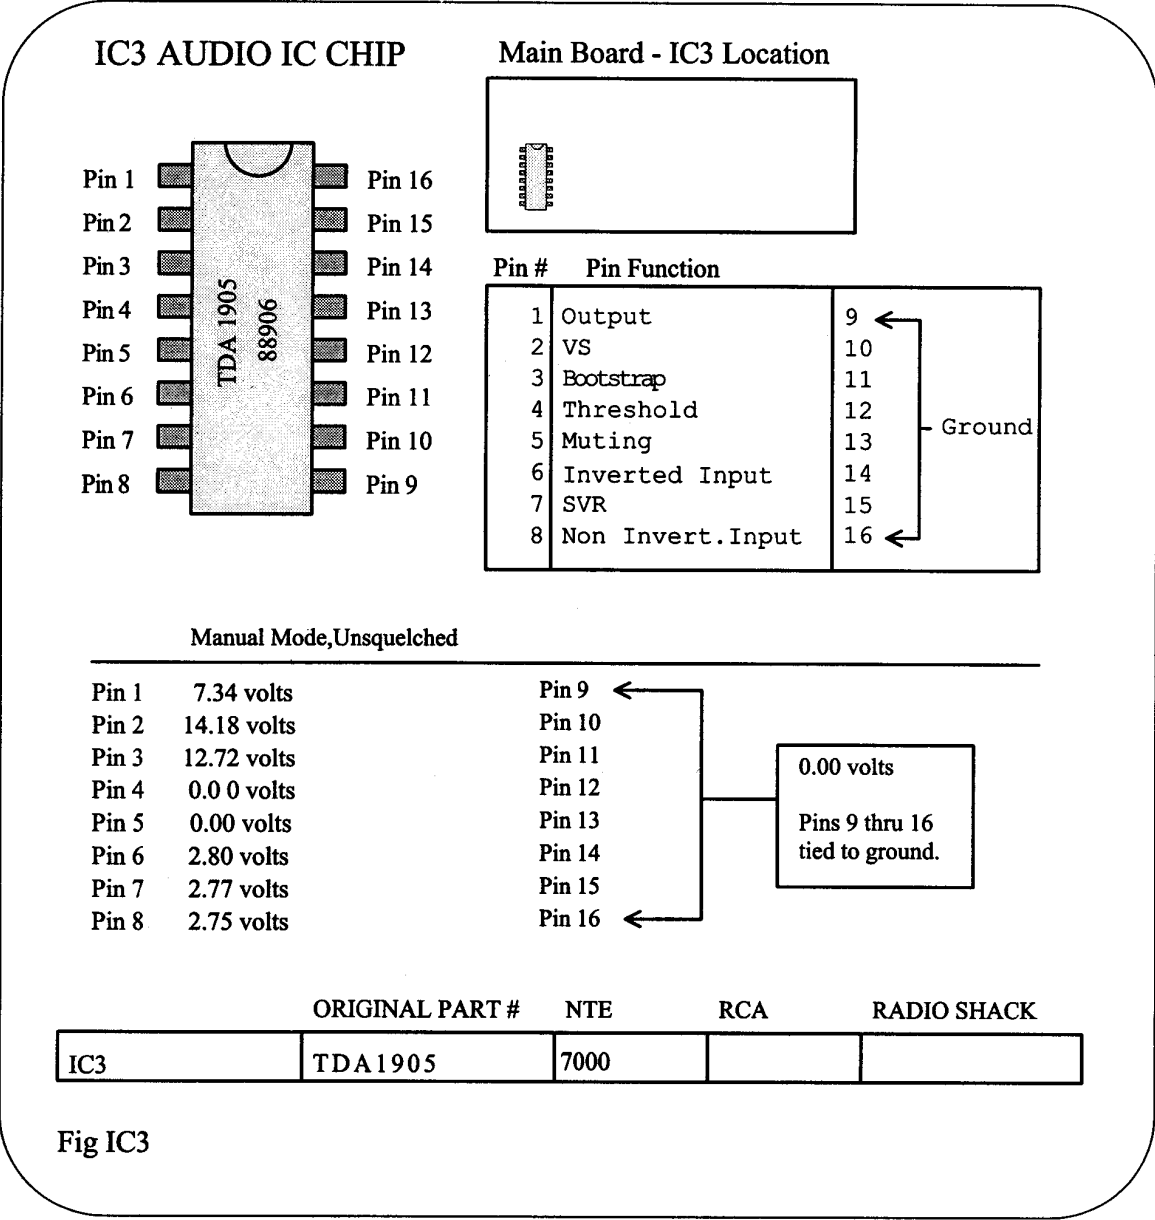
Uniden® BC-800XL
IC3 Audio Chip Layout

PROBLEM: Distorted Audio, Speaker Sounds Bad, however unit still sounds distorted with an external speaker connected. Voltages check OK on Audio Chip.

CURE : This problem has been traced to the coupling capacitor (C75) which connects the Audio Chip output on Pin 1 to the speaker and/or the feedback capacitor (C73) connected between Pin 3 and Pin 1 of the Audio Chip. C75 is a 47uf 16 Volt electrolytic capacitor, and C73 is a 47uf 10 volt electrolytic capacitor. First you will need two replacement capacitors. A 47uf electrolytic (16 volt or higher) and a 220uf electrolytic (25 volt or higher). Next replace C75 with the new 220uf electrolytic and replace C73 with the new 47uf electrolytic. Observe polarity when replacing. Not only should this eliminate the problem, it will also greatly improve the scanner's audio quality.

NOTE: At the present time there is no substitute available for the TDA1905 IC from RCA or Radio Shack®. We left the substitute area blank in order for you to fill in when substitute replacements are available.....
